COST AND PERFORMANCE TRENDS IN GRID-CONNECTED PHOTOVOLTAIC SYSTEMS AND CASE STUDIES

Report IEA-PVPS T2-06:2007

December 2007

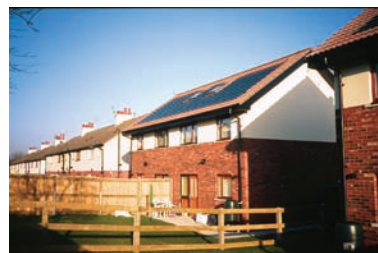
All roofs are at an angle of 35°. The PV tiles are designed to fit in with the conventional tiles' horizontal lines resulting in flushness with the roof. Also the contrast in colour between the red tiles and blue PV modules was deliberate. The overall result is an uncluttered roof with an eye-catching PV system.

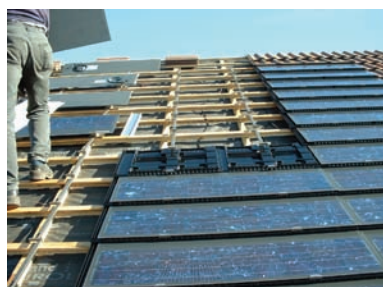
There were some minor problems with the PV-roof integration. For example, on the first completed roof, the roofer placed the felt between the counter battens and battens instead of underneath both, thus reducing the ventilation air gap. Emphasising the correct sequence of the counter battening here is crucial as this will be unusual practice to roofers.

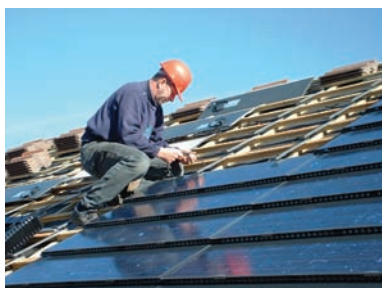
The roofers made the electrical connections between the modules as they progressed, using Multi-Contact (MC) connectors, which are touch-safe. The connections were made as straightforward as possible by installing the modules in columns to form a string from bottom to top. The strings comprised ten or twelve modules depending on the site. The PV contractor returned to test the continuity of the strings after the modules were installed and before the scaffolding came down.
